Architectural
Resources Group

Architecture
Planning
Conservation

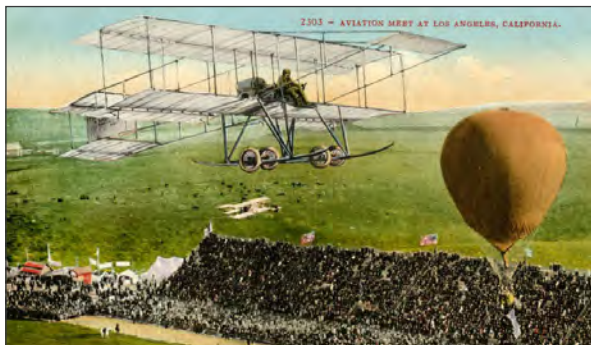
Postcard of the Aviation Meet in Dominguez Hills, 1910 (Los Angeles Public Library).

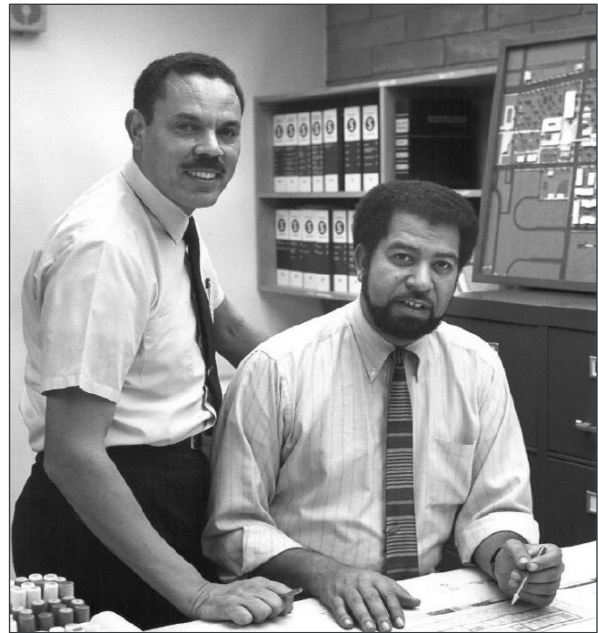
Robert Kennard and Arthur Silvers, 1960s (Estate of Robert Kennard).

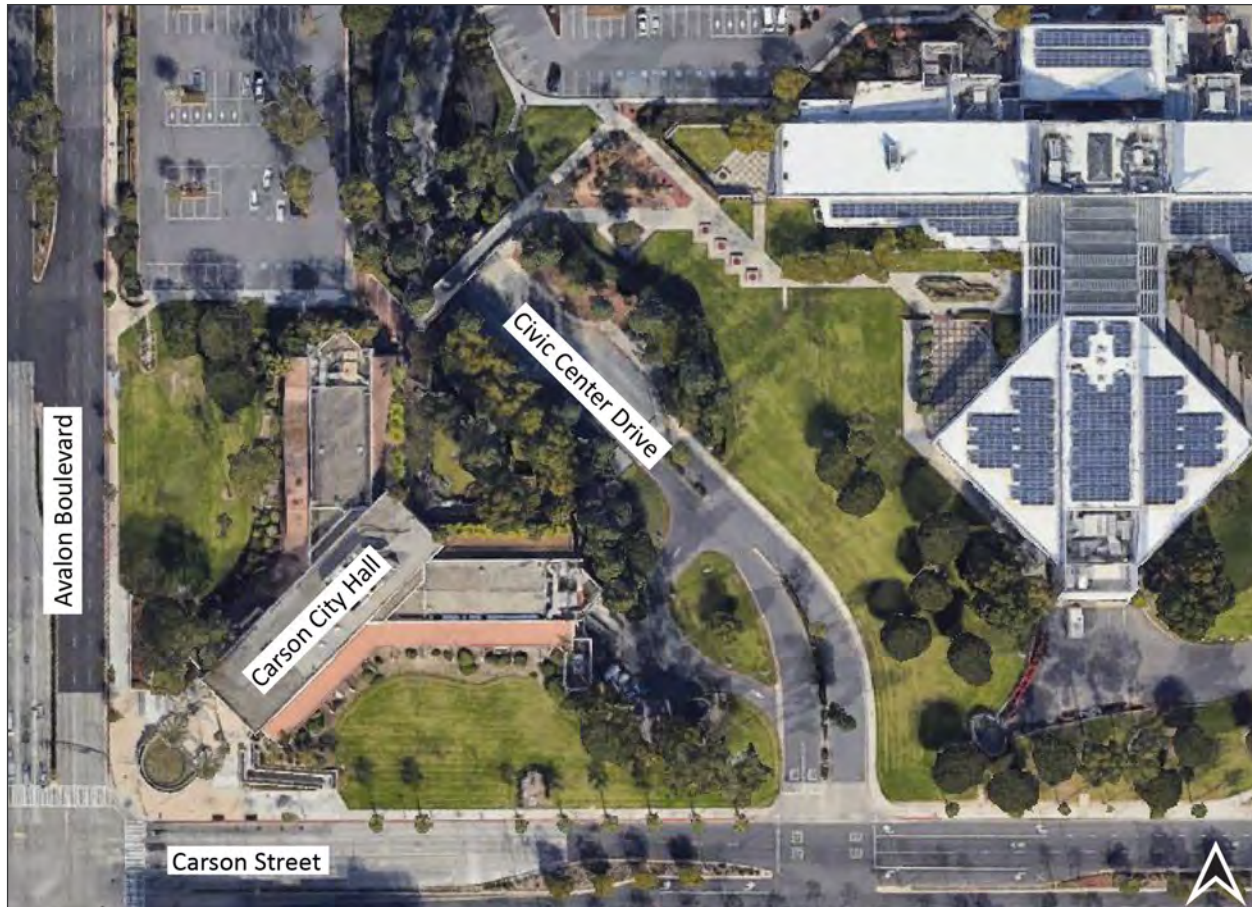
Aerial photograph of Carson City Hall and a portion of the Carson Civic Center site, with Carson Community Center to the east. Note original west and south lawns around the building are still present (replaced with drought tolerant landscaping in 2023) (Google Earth, 2023; adapted by ARG, 2024).

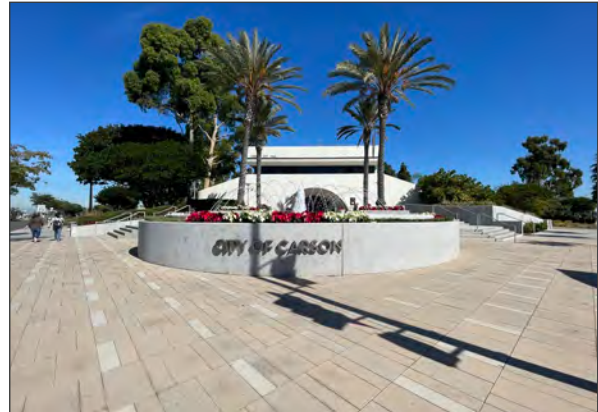
View northeast of the south entrance plaza, redeveloped 2016-17 (ARG, 2023).

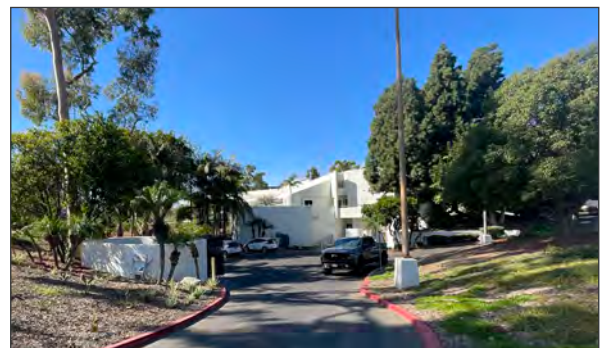
View west of the east parking/loading area (ARG, 2023).

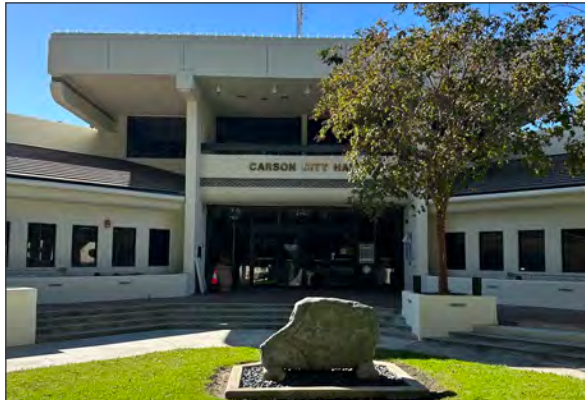
View southwest of the southwest wing's north façade (ARG, 2023).

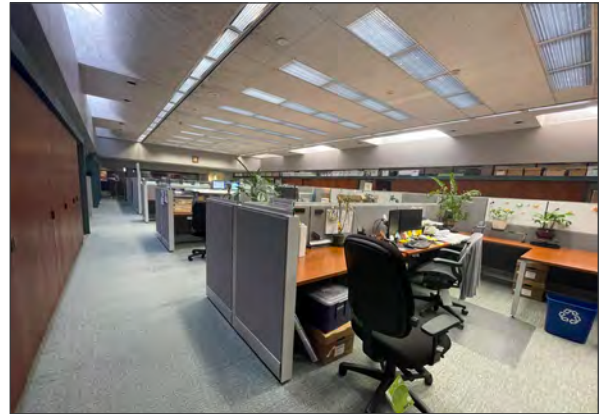
View of the first floor open office space within the north wing (ARG, 2023).

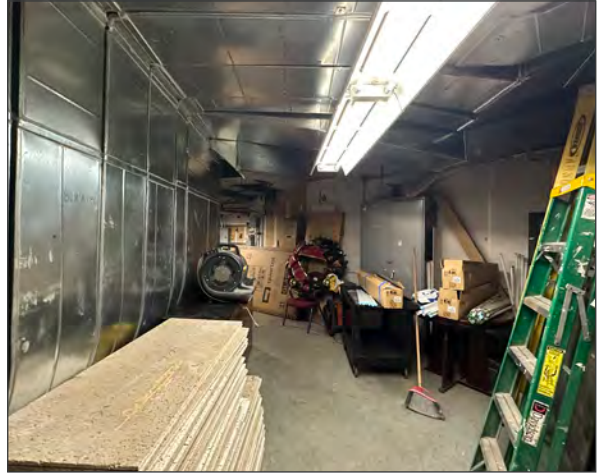
Basement air handling unit (ARG, 2023).

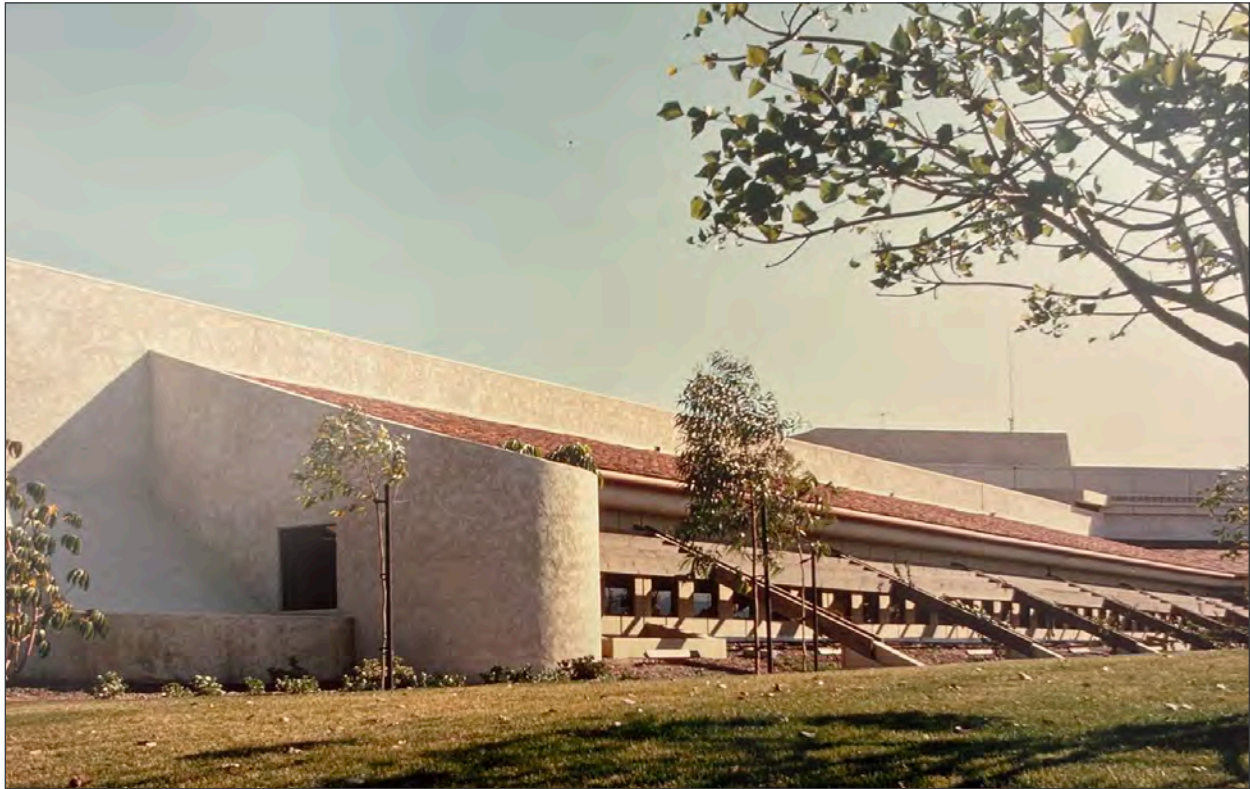
View of the north wing's characteristic projecting shed roof volume, wood trellis/bris soleil, and grouped fixed aluminum windows, ca. 1976 (UCLA Special Collections).

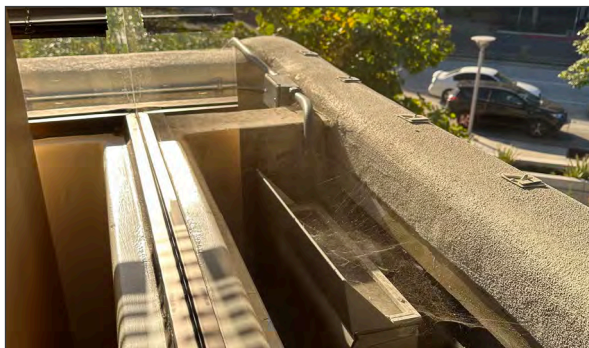
Exterior planter at the second floor that wraps around to the southwest wing, east and west façades (ARG, 2023).

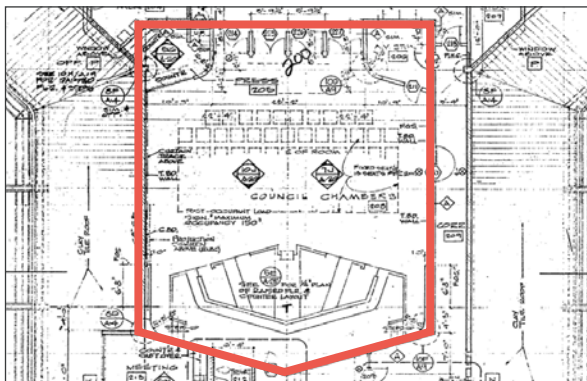
Council chambers' pentagon-shaped floor plan (Alexander, Kennard, and Sata, 1974-75).

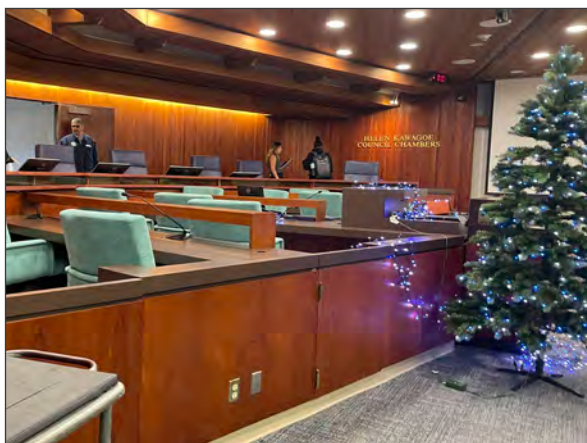
Low wood wall separating rostrum from seating area and cedar plank ceiling with can lights above the rostrum in the council chambers (ARG, 2023).

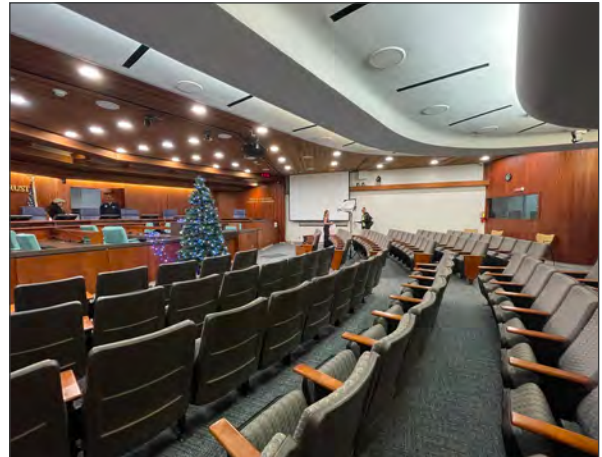
Slightly sloped council chambers seating area and plaster ceiling with stepped curved pattern and soffit lighting (ARG, 2023).

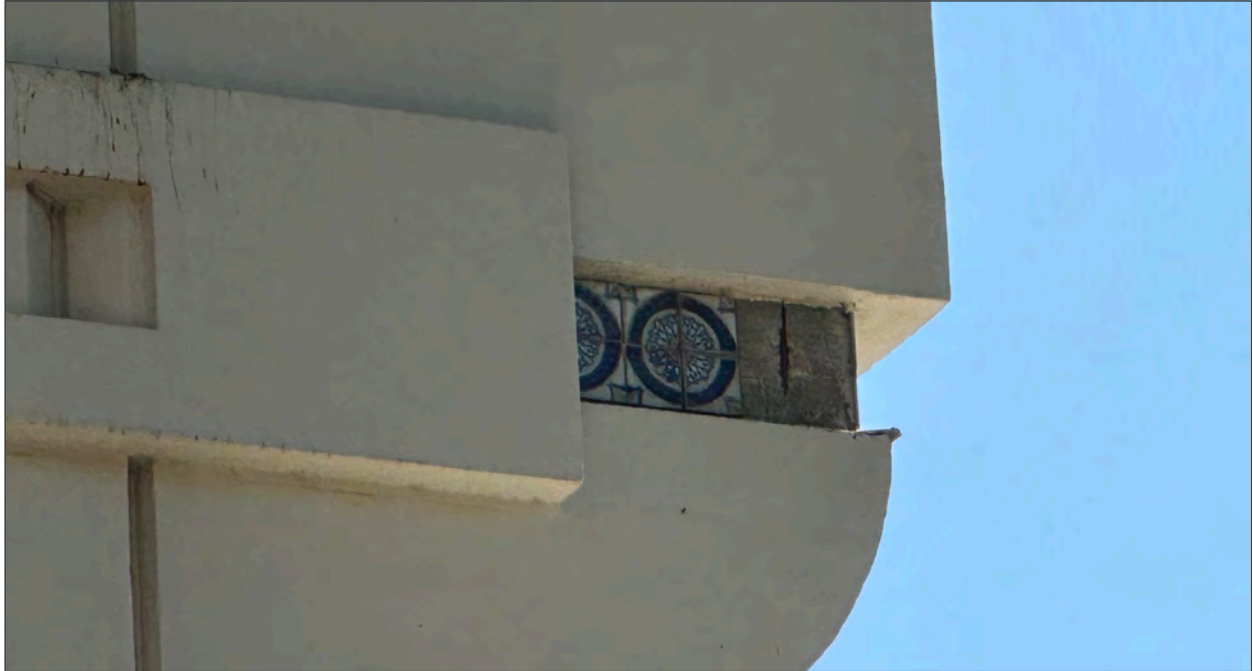
Missing tile at overhang above south entrance (ARG, 2023).

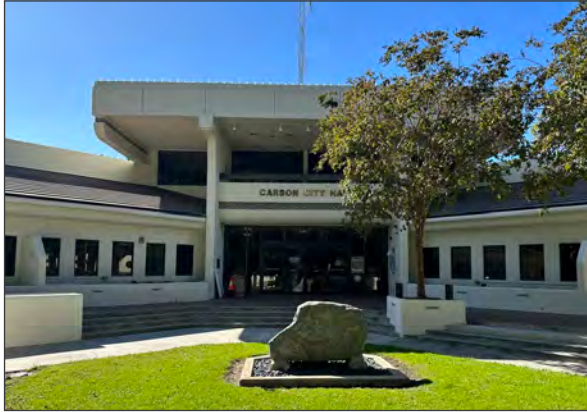
View south of the southwest (center), east (left) and north (right) wings (ARG, 2023).

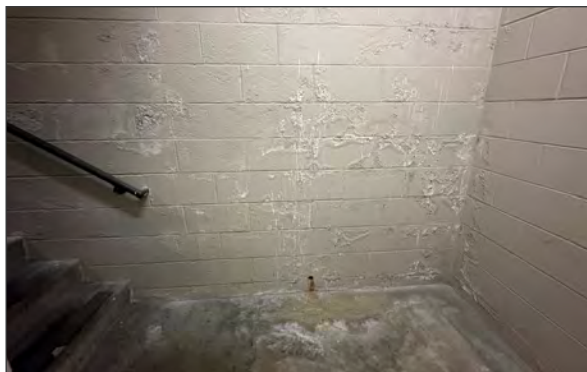
Peeling paint and water stains at CMU basement wall (ARG, 2023).

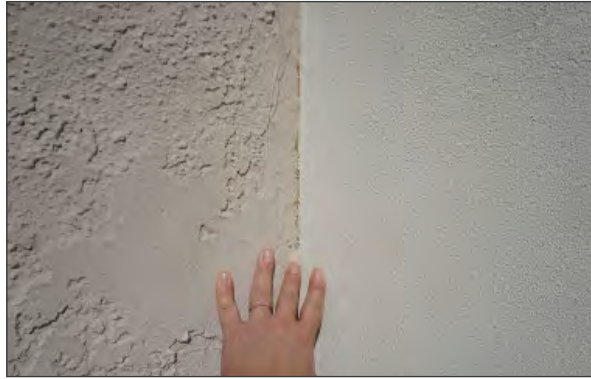
Original textured stucco (left) and new smooth stucco (right) (WJE, 2023).

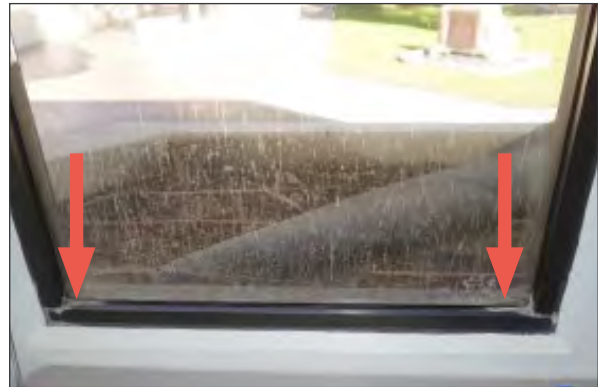
Interior view of water staining at window corners (WJE, 2023).

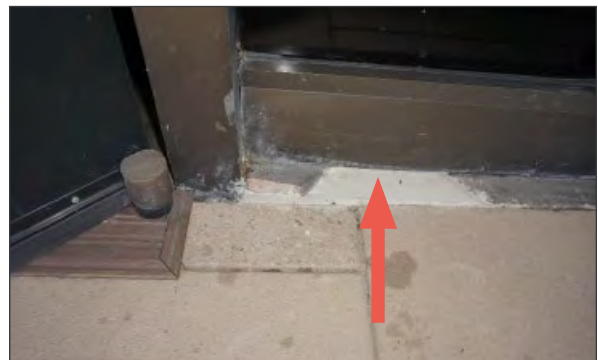
View of storefront system sill from the exterior. Exposed concrete floor slab and evidence of repair indicated by red arrow (WJE, 2023).

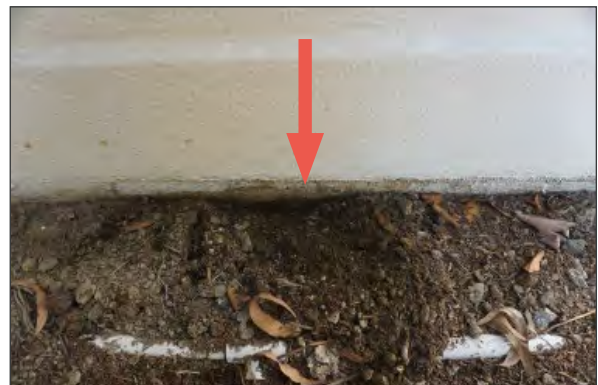
Exposed wall condition at planters with exposed mesh reinforcement at new plaster finish indicated by red arrow (WJE, 2023).

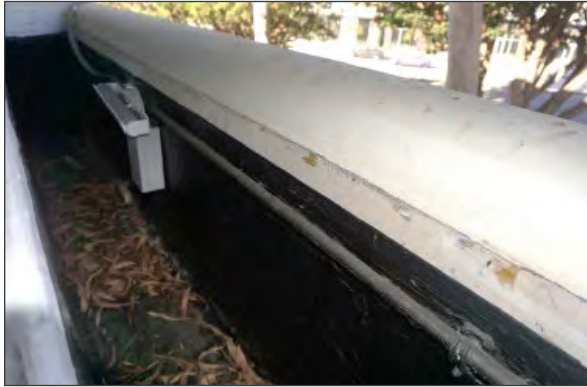
Typical exterior second floor planter (WJE, 2023).

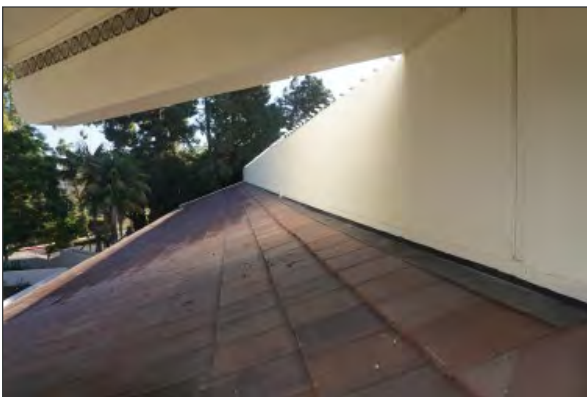
Tile roof on the lower volume of the east wing (WJE, 2023).

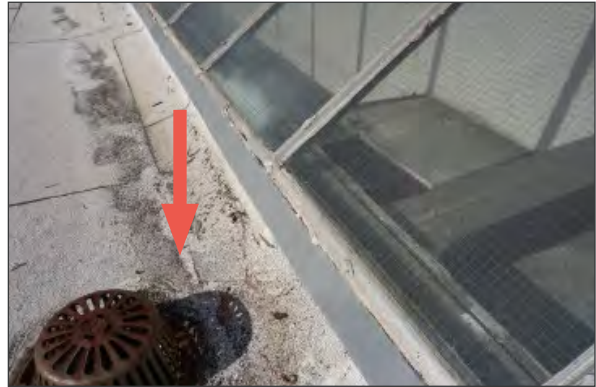
View of debris and granule accumulation at roof low spots , indicated by red arrow (WJE, 2023).

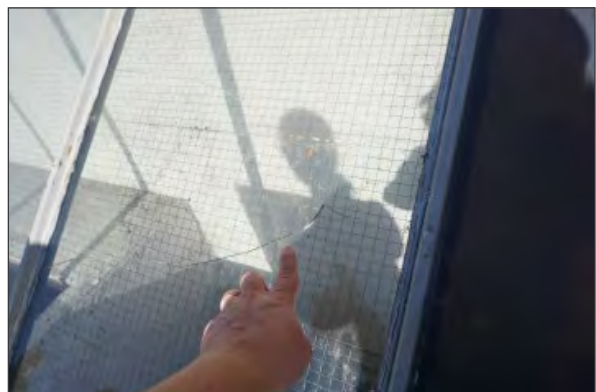
Close-up of cracked skylight glass (WJE, 2023).

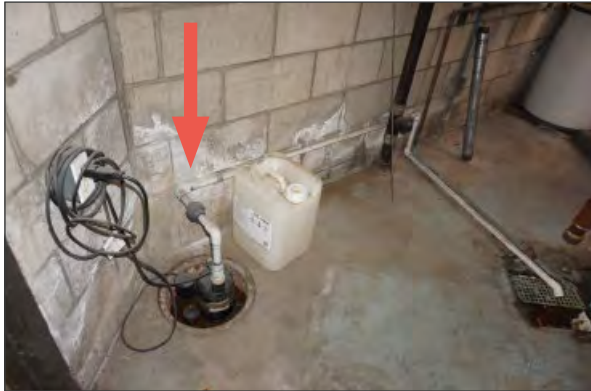
Typical efflorescence on CMU foundation walls, indicated by red arrow (WJE, 2023).

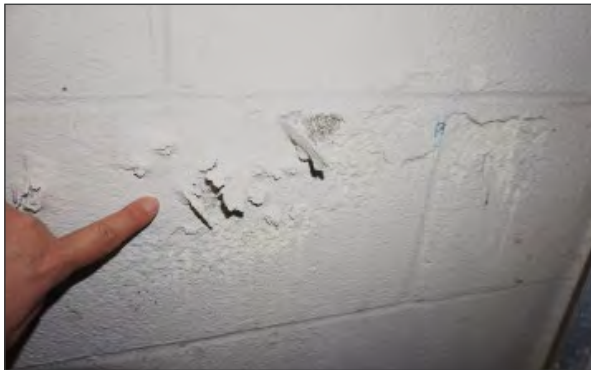
Blistering and debonded paint on CMU foundation walls (WJE, 2023).

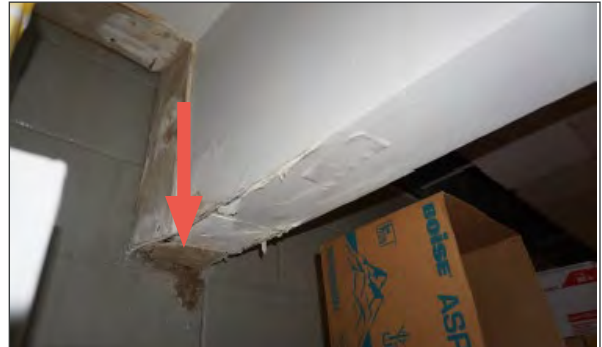
Moisture damage on gypsum wall boards abutting the CMU foundation wall, indicated by red arrow (WJE, 2023).

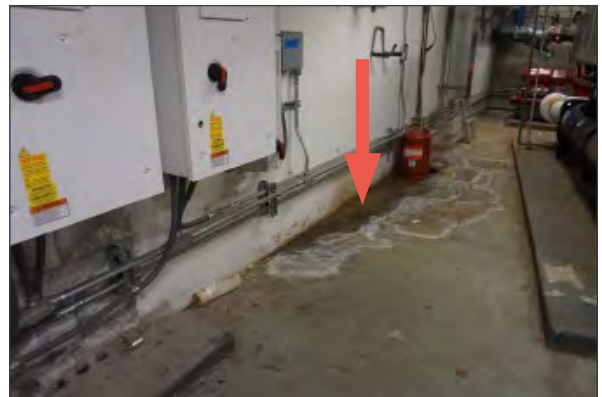
Ponding water and water stains in basement chiller room, indicated by red arrow (WJE, 2023).

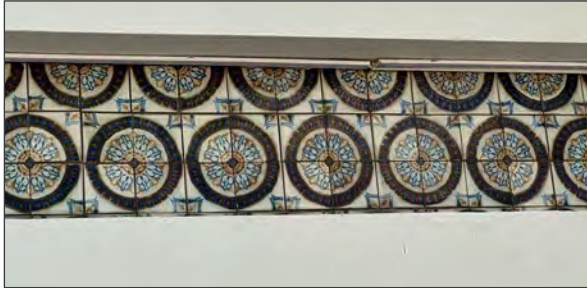
Detail of polychromatic “Spanish ceramic tile” band (ARG, 2023).

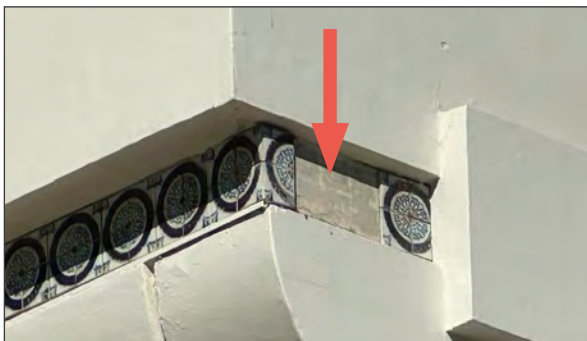
Detail of missing tile above southwest wing (ARG, 2023).

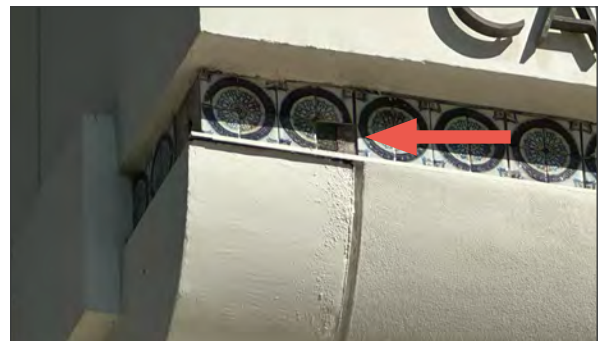
Detail of missing tile above southwest wing (ARG, 2023).

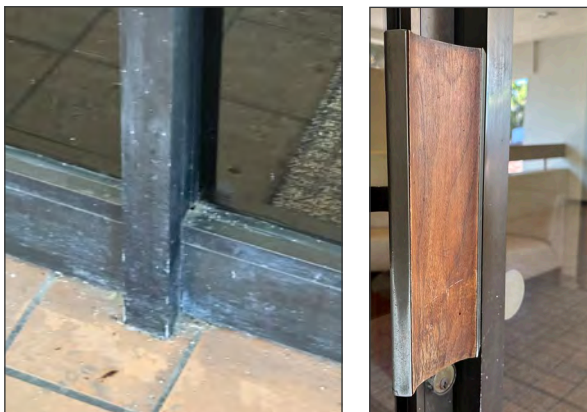
Oxidation at aluminum storefront (left) and irregular surface wear at cedar door pull (ARG, 2023).

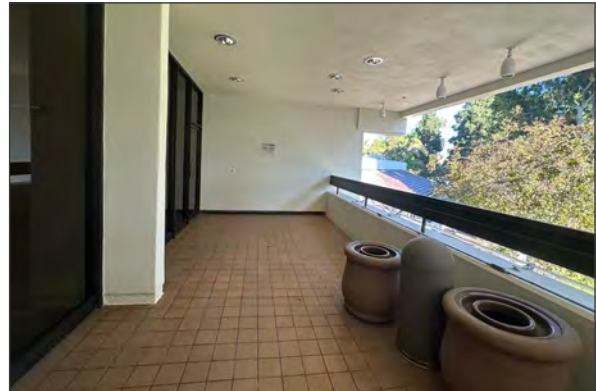
Decorative railing at the southwest wing, second-floor balcony (ARG, 2023).

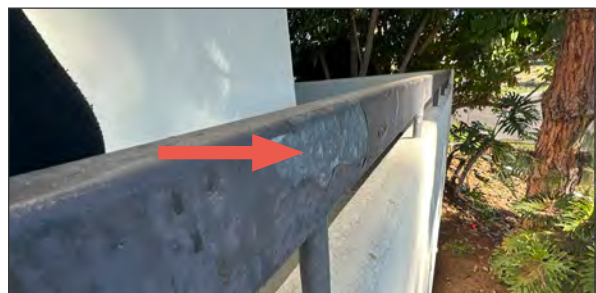
Peeling paint at balcony railing at the east end of the east wing, indicated by red arrow (ARG, 2023).

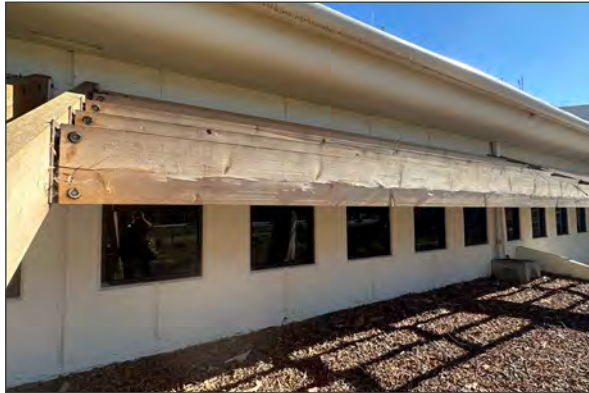
Checking and splits at wood trellis framing (ARG, 2023).

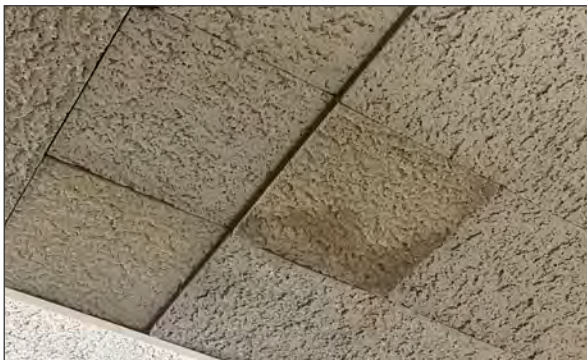
Detail of stained acoustical tiles (ARG, 2023).

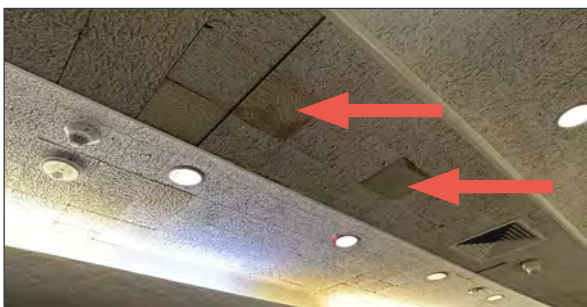
Stained and damaged ceiling tiles, as indicated by red arrows (ARG, 2023).

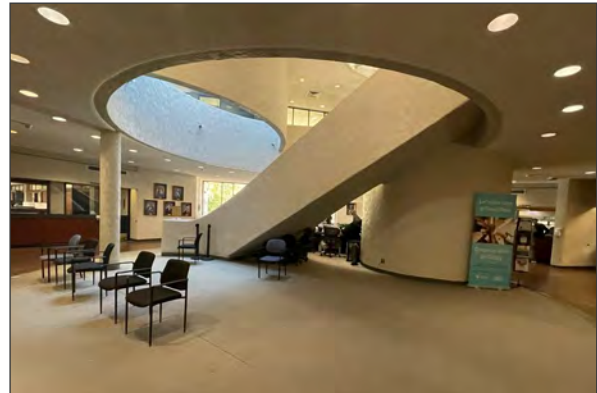
First floor lobby (ARG, 2023).

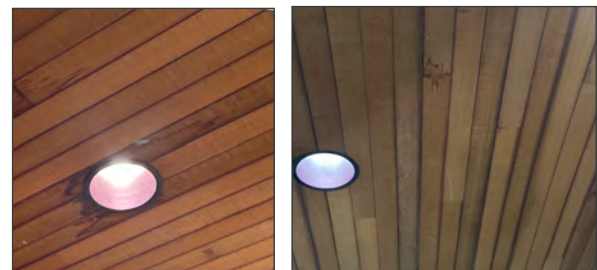
Detail of water stains (left) and warped/loose boards at wood ceiling (ARG, 2023).

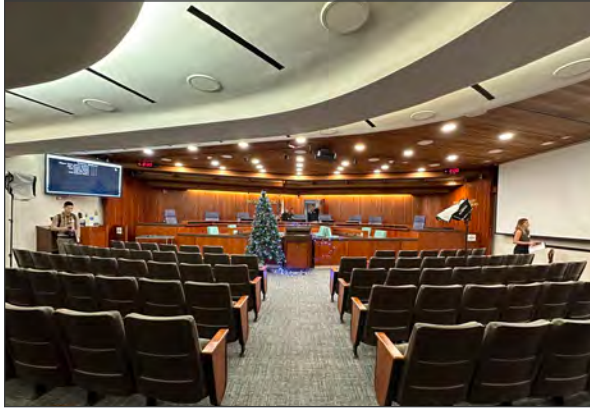
View of council chambers (ARG, 2023).

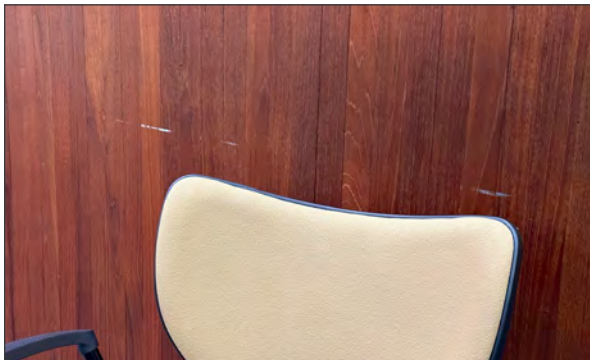
Detail of abrasion marks at wood paneling associated with loose chair seating (ARG, 2023).

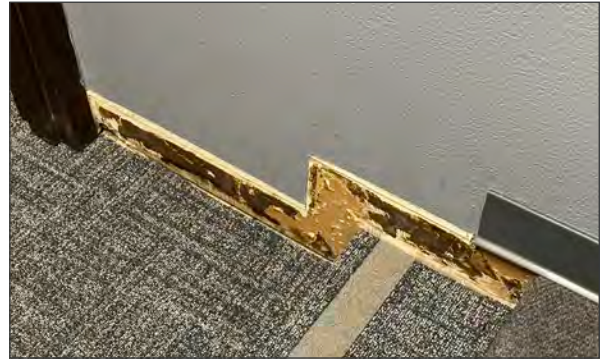
Detail of missing rubber base trim along the west interior wall (ARG, 2023).

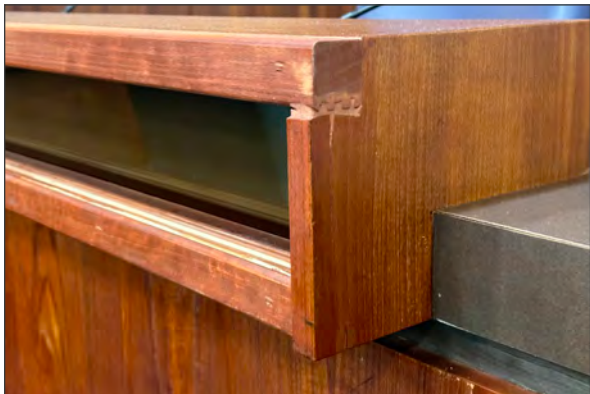
Damage at council desk millwork (ARG, 2023).

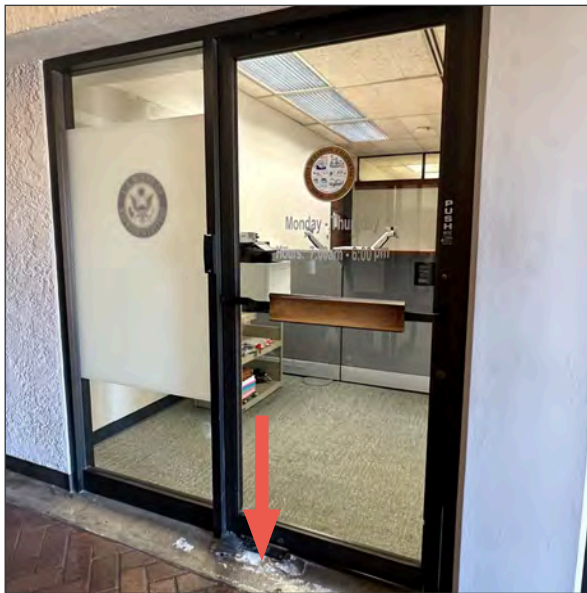
Damaged concrete threshold at corridor office doors, indicated by red arrow (ARG, 2023).

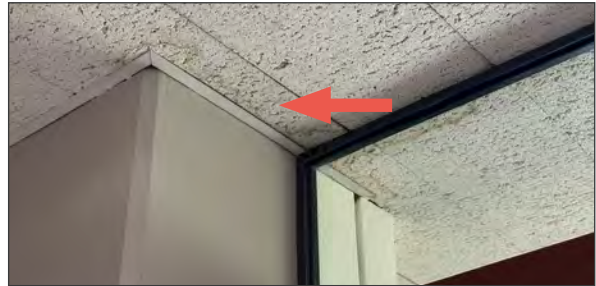
Localized areas of water stains at acoustical tiles, indicated by red arrow (ARG, 2023).

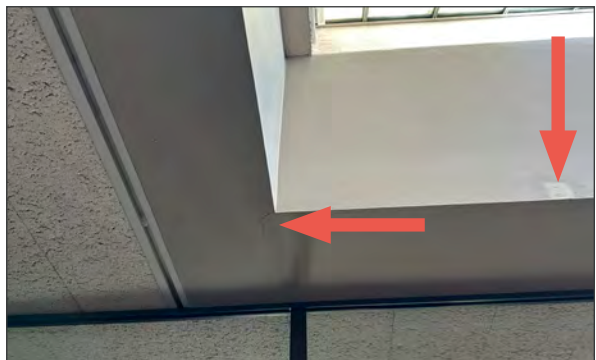
Localized areas of crack at plaster (left arrow) and peeling paint (right arrow) (ARG, 2023).

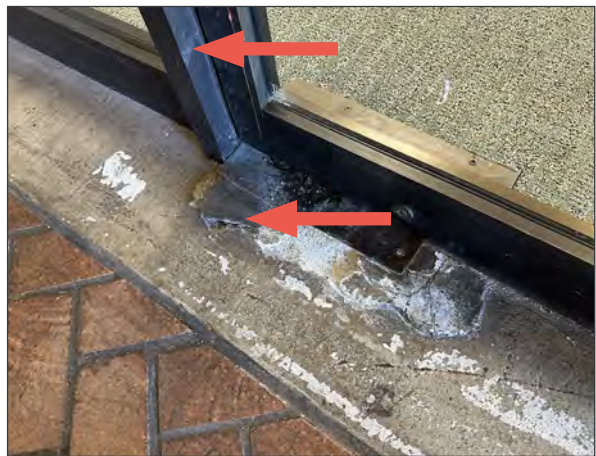
Detail of concrete damage, poor previous patches, and oxidation of aluminum storefronts, indicated by red arrows (ARG, 2023).

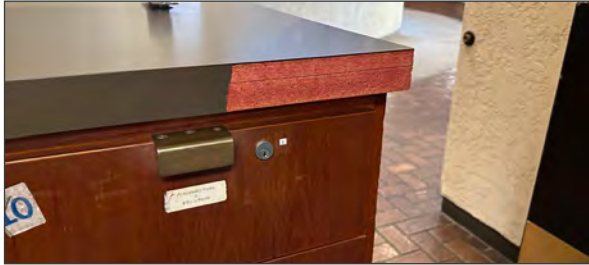
Missing plastic laminate at countertop (ARG, 2023).

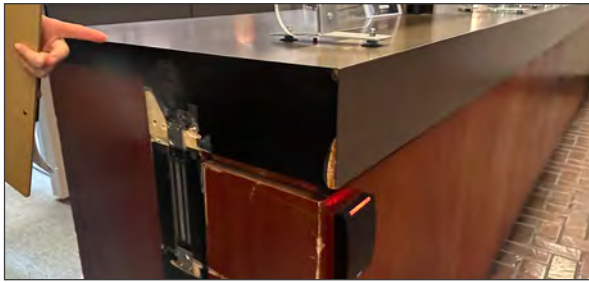
Missing gate/door at counter and damaged laminate countertop (ARG, 2023).

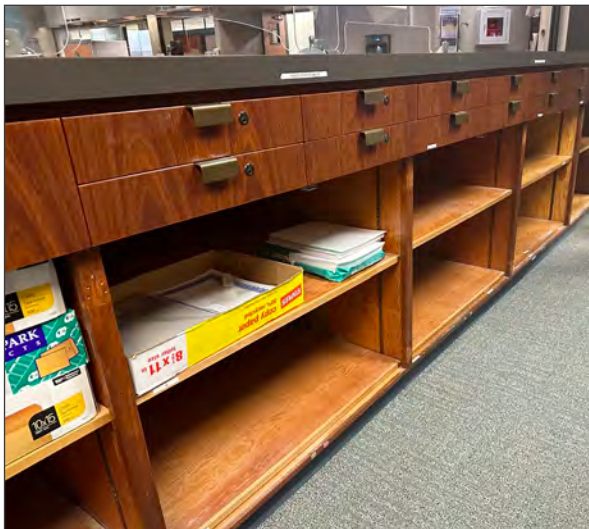
Missing cabinet doors at counters (ARG, 2023).

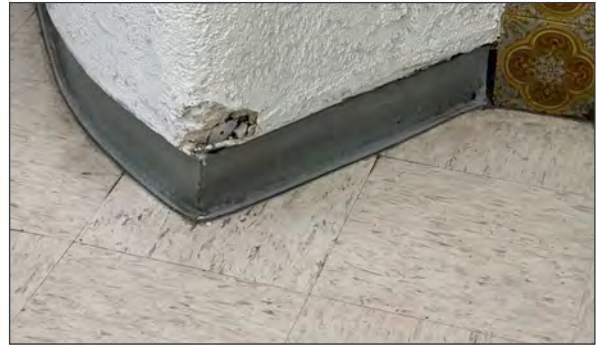
Spalled plaster next to the basement elevator (ARG, 2023).

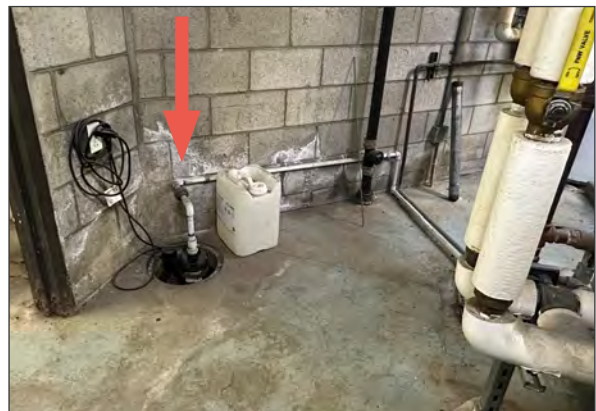
Efflorescence at the CMU wall in the chiller room, indicated by red arrows (ARG, 2023).

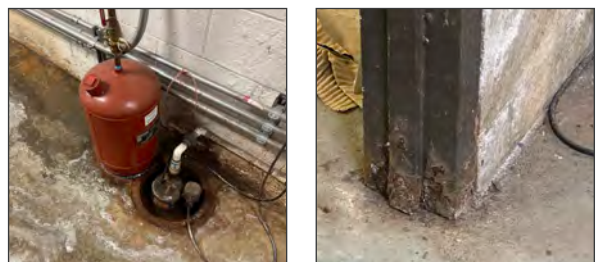
Water staining and ponding in chiller room (left) and corrosion at door entry (right) (ARG, 2023).

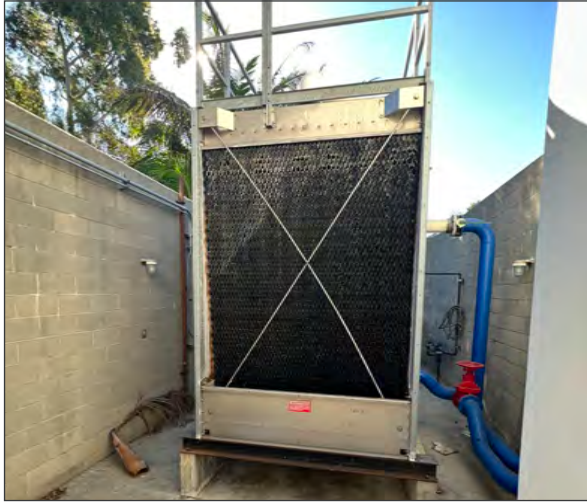
Cooling tower at roof (ARG, 2023).

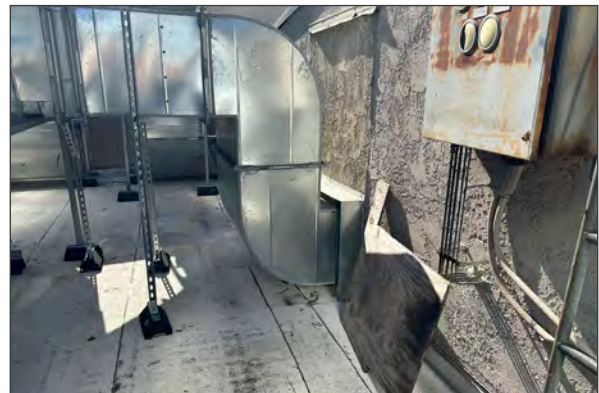
Air handling unit at roof (ARG, 2023).

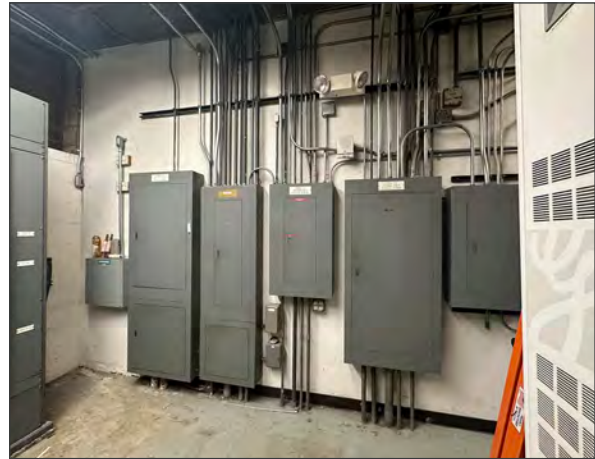
Basement main electrical room (ARG, 2023).

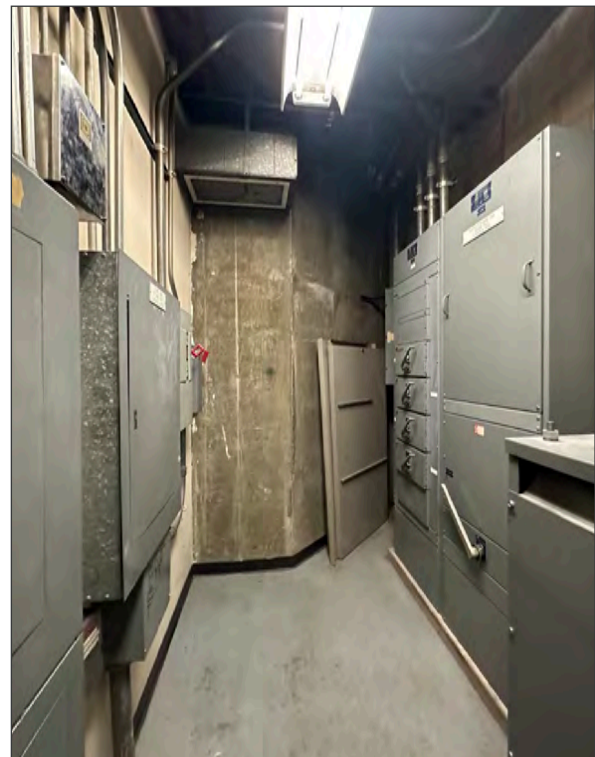
Basement electrical substation (ARG, 2023).

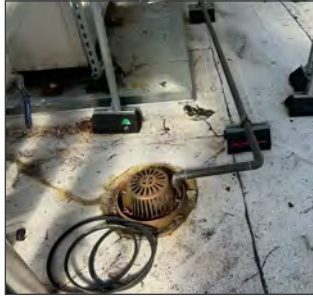
Roof scuppers (ARG, 2023).

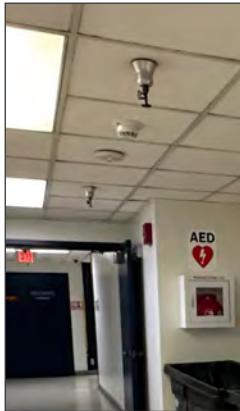
Basement fire sprinklers (left) and typical restroom lavatories (right) (ARG, 2023).

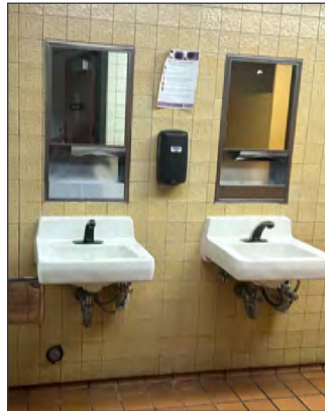
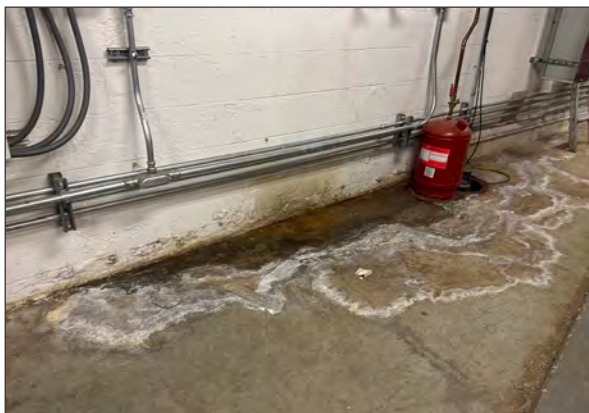
Water ponding in basement chiller room, possibly due to submersible pumps not working (ARG, 2023).

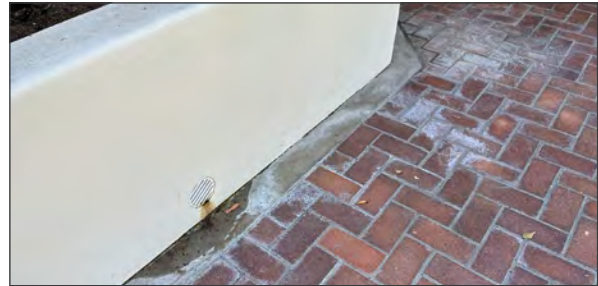
Heavy water stains and efflorescence at brick paving (ARG, 2023).

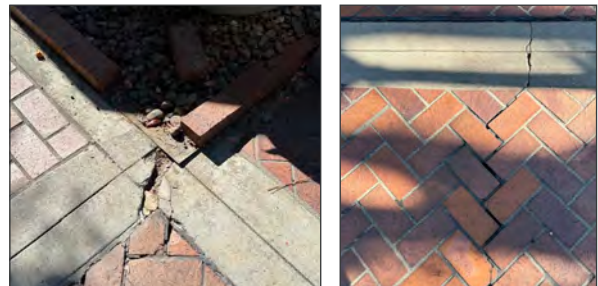
Concrete paving spalls (left) and cracked brick paving (right) (ARG, 2023).

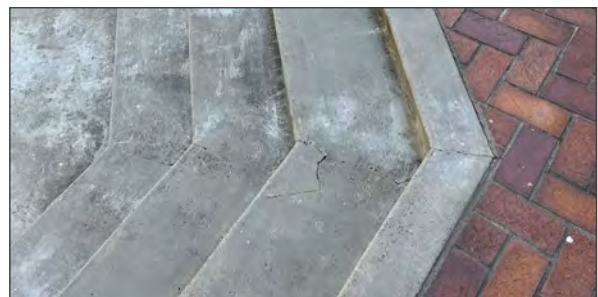
Cracking and efflorescence at concrete steps (ARG, 2023).

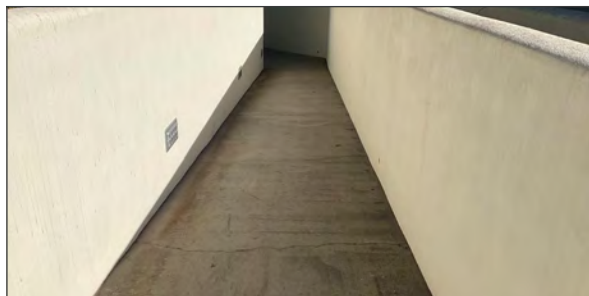
Cracking at concrete ramp to lower east garden (ARG, 2023).

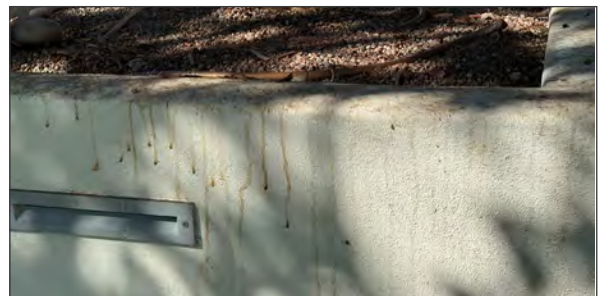
Water stains at concrete planter walls (ARG, 2023).

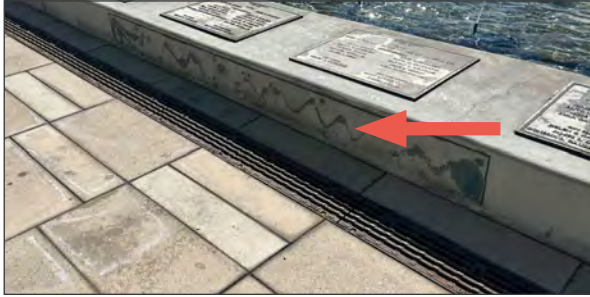
Missing tiles at plaza fountain, indicated by red arrow (ARG, 2023).

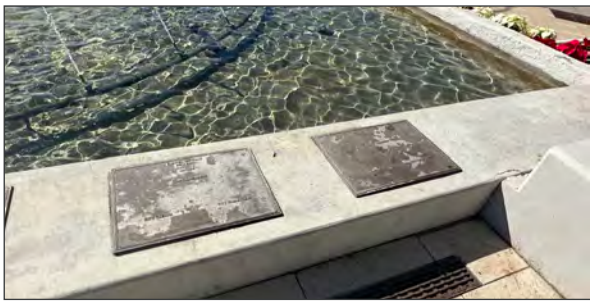
Deteriorated plaques at plaza fountain (ARG, 2023).

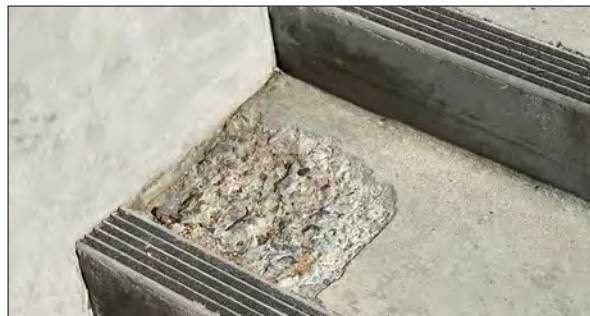
Detail of concrete spall at plaza steps (ARG, 2023).

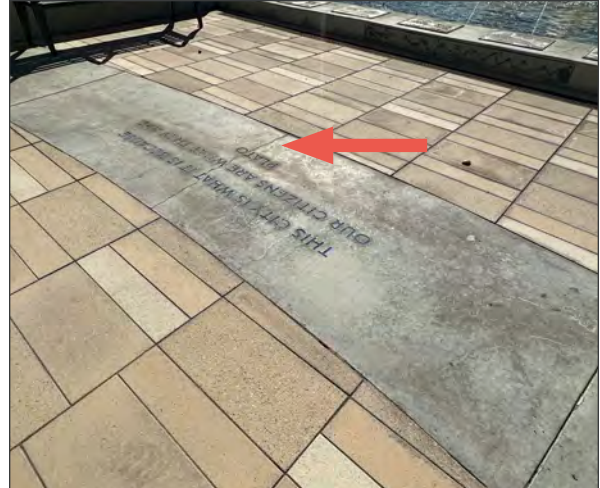
Crack at engraved concrete paving, indicated by red arrow (ARG, 2023).

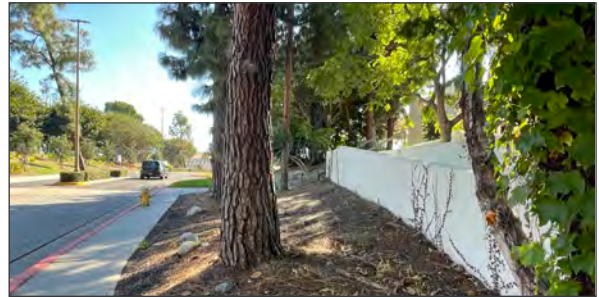
Close-up of original Canary Island pine at Civic Center Drive (MIG, 2023).

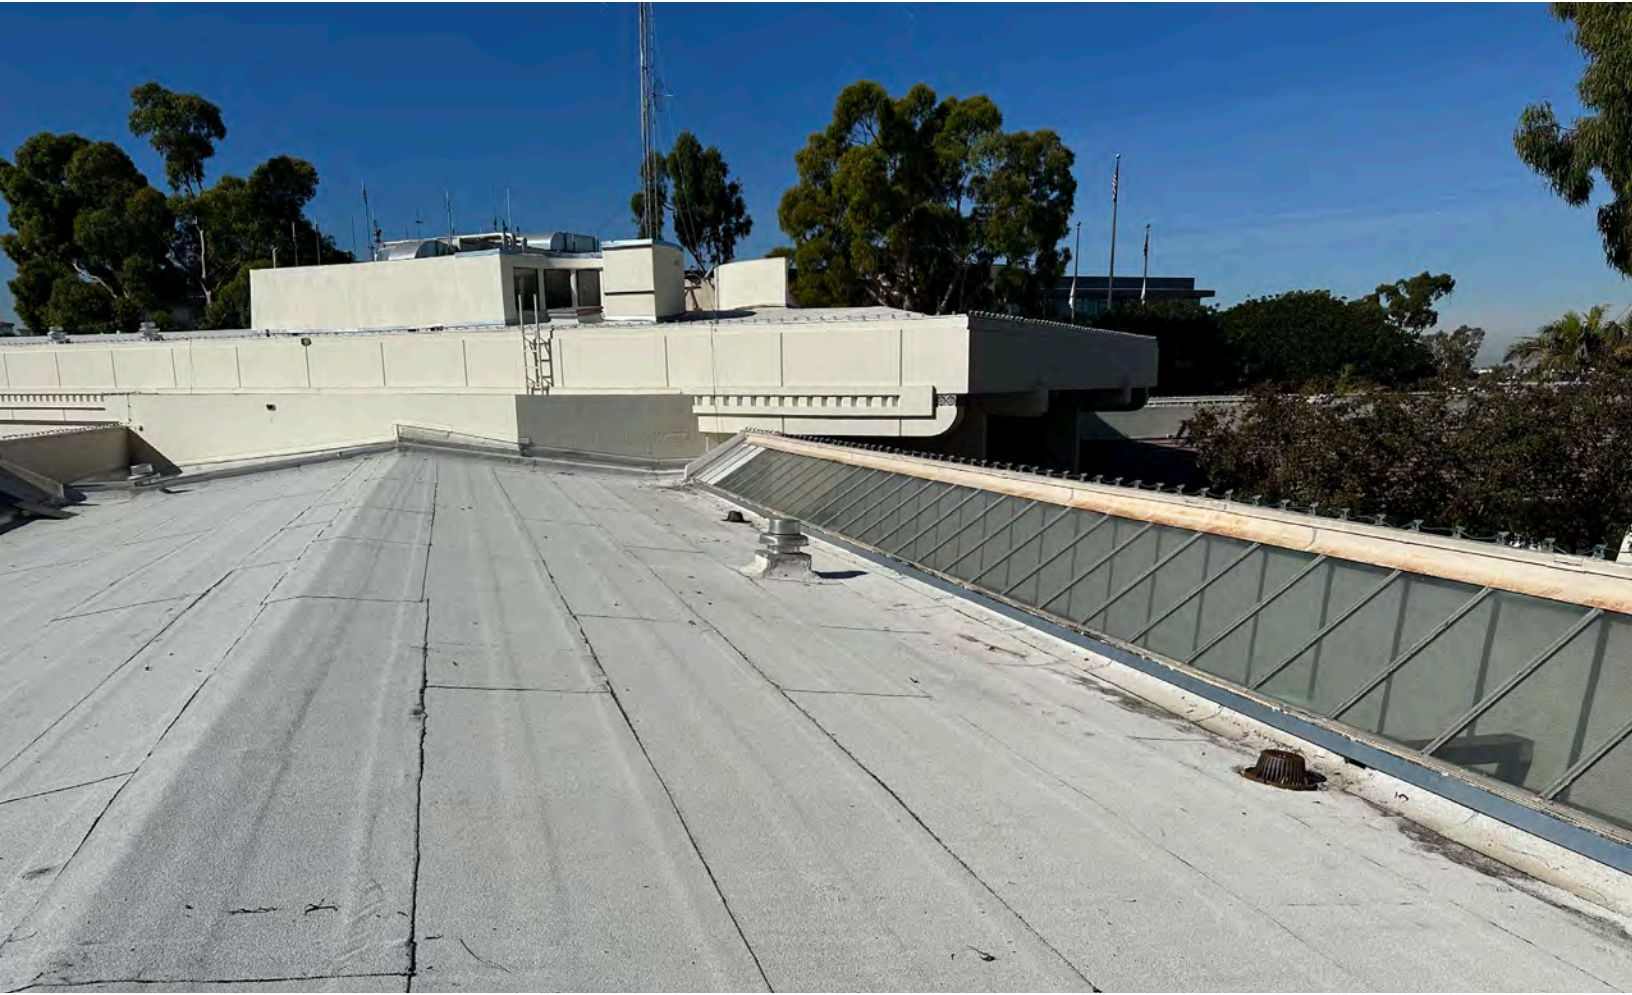
this page was intentionally left blank

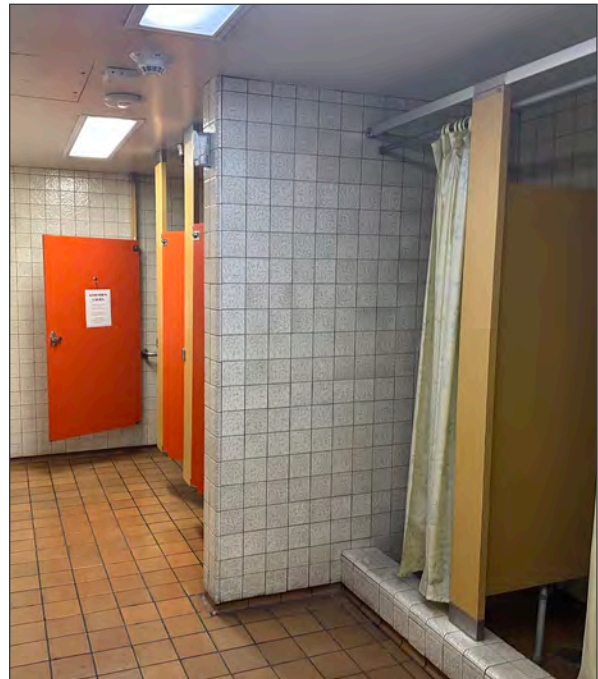
Basement women’s restroom (ARG, 2023).

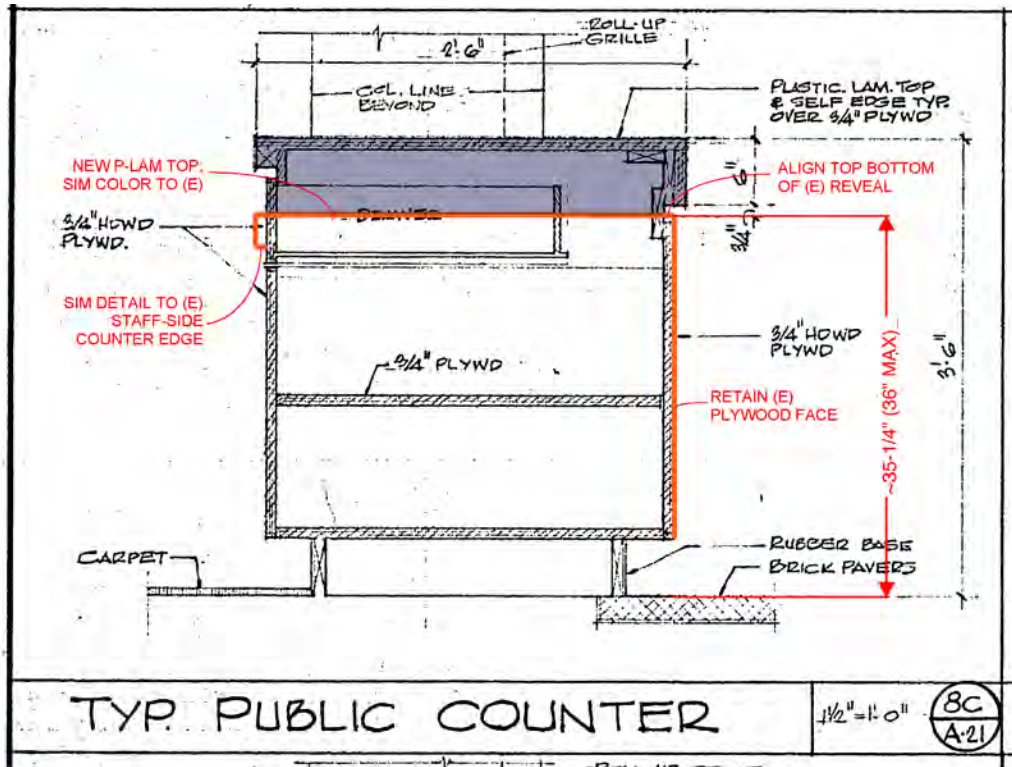
CARSON CITY HALL
ACCESSIBLE COUNTER CONCEPT
29 JAN 2024

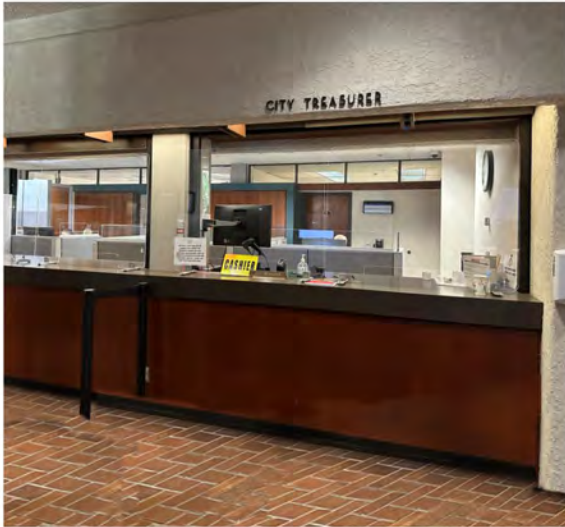
Treatment Recommendations

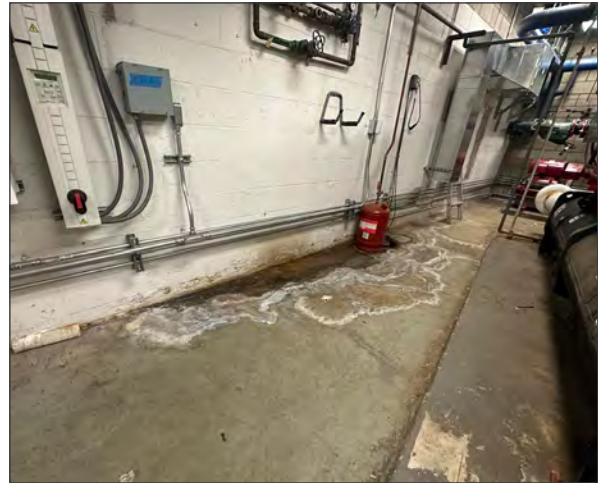
Basement chiller room (ARG, 2023).
