INTERIM ENGINEERING OBSERVATIONS & ASSESSMENT REPORT

**Forensic Cast Iron Sewer Pipe Study
Former Kast Property
Carousel Tract Residences
City of Carson, CA**

September 14, 2017

Project No. 01176-001

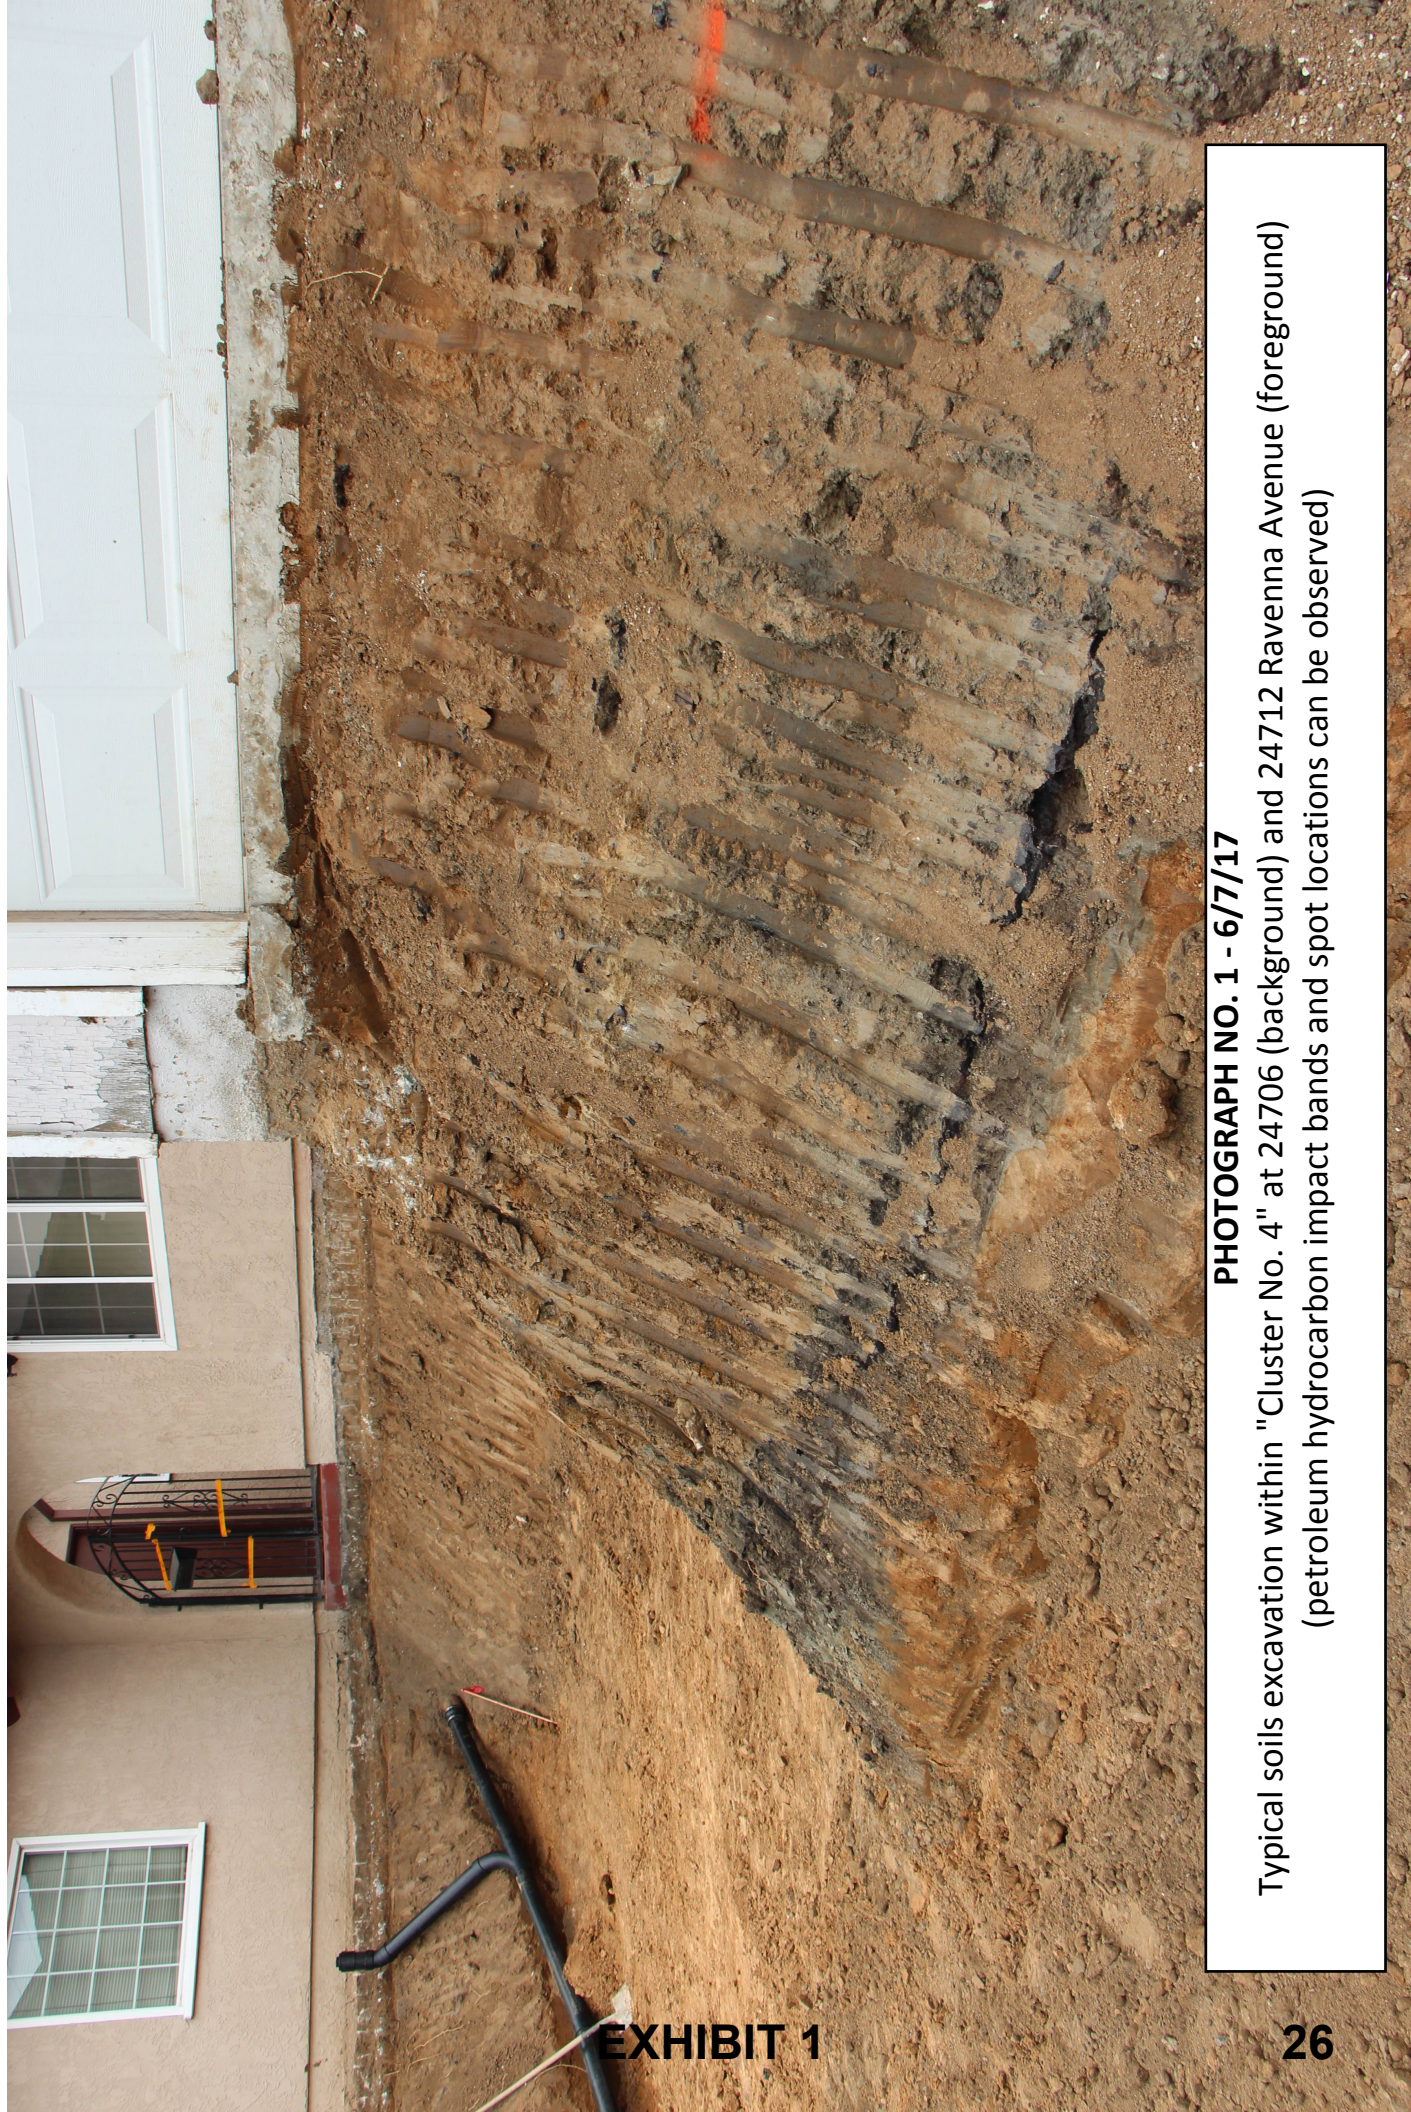
PHOTOGRAPH NO. 1 - 6/7/17

Typical soils excavation within "Cluster No. 4" at 24706 (background) and 24712 Ravenna Avenue (foreground)
(petroleum hydrocarbon impact bands and spot locations can be observed)

There was no real identifiable pattern as to where petroleum hydrocarbon impact was observed or located or to what degree, either in lateral spread or according to depth. Photograph No. 1 below shows a typical excavation within the Cluster No. 4 area. Obvious petroleum hydrocarbon impact bands and spot locations can be observed as gray and black areas of discoloration.

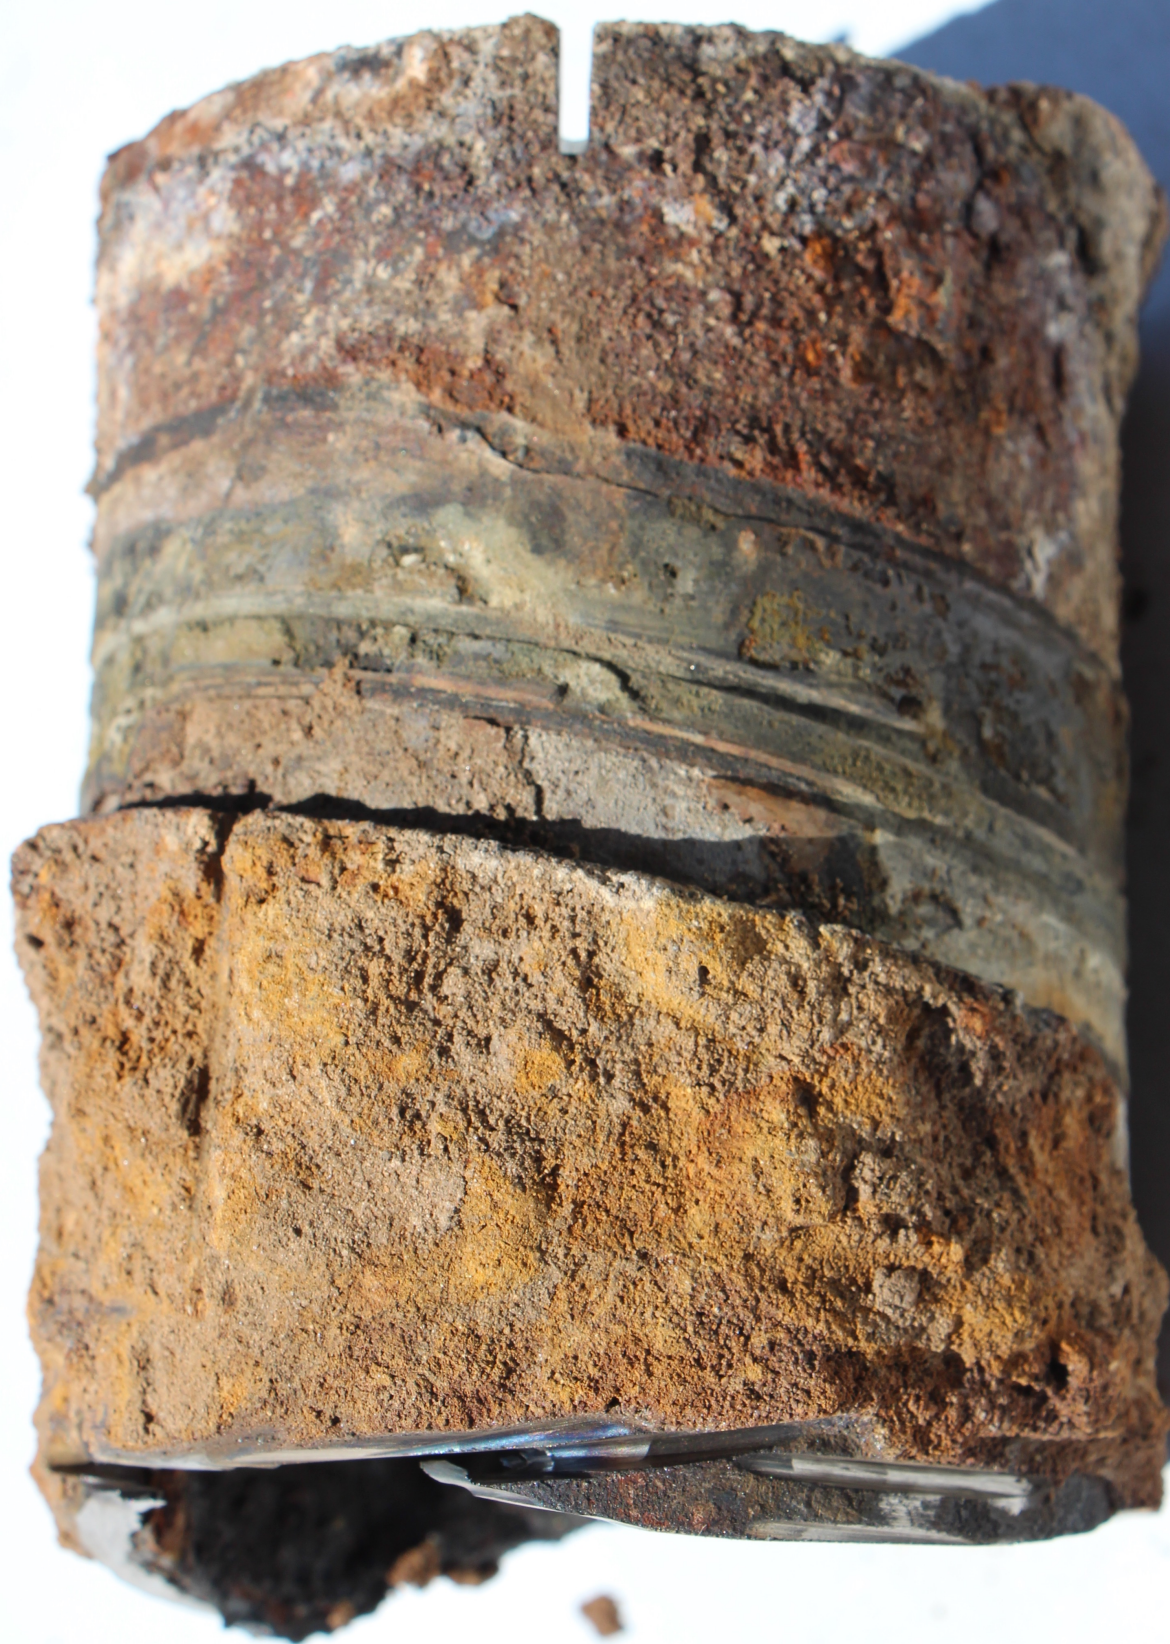
PHOTOGRAPH NO. 2 - 6/13/17

Cast iron sewer pipe specimen removed from 24602 Neptune Avenue.

The left section of the pipe exhibits a naturally occurring protective scale. The right section of the pipe does not as it was covered by a rubberized pipe connecting band.

Photograph No. 2, attached below, shows a cast iron sewer pipe specimen removed that displays a naturally-occurring protective outer and inner scale. The part of this pipe segment that appears rusted and corroded did not have an outer scale that formed because it was located beneath a rubberized no-hub pipe connection.

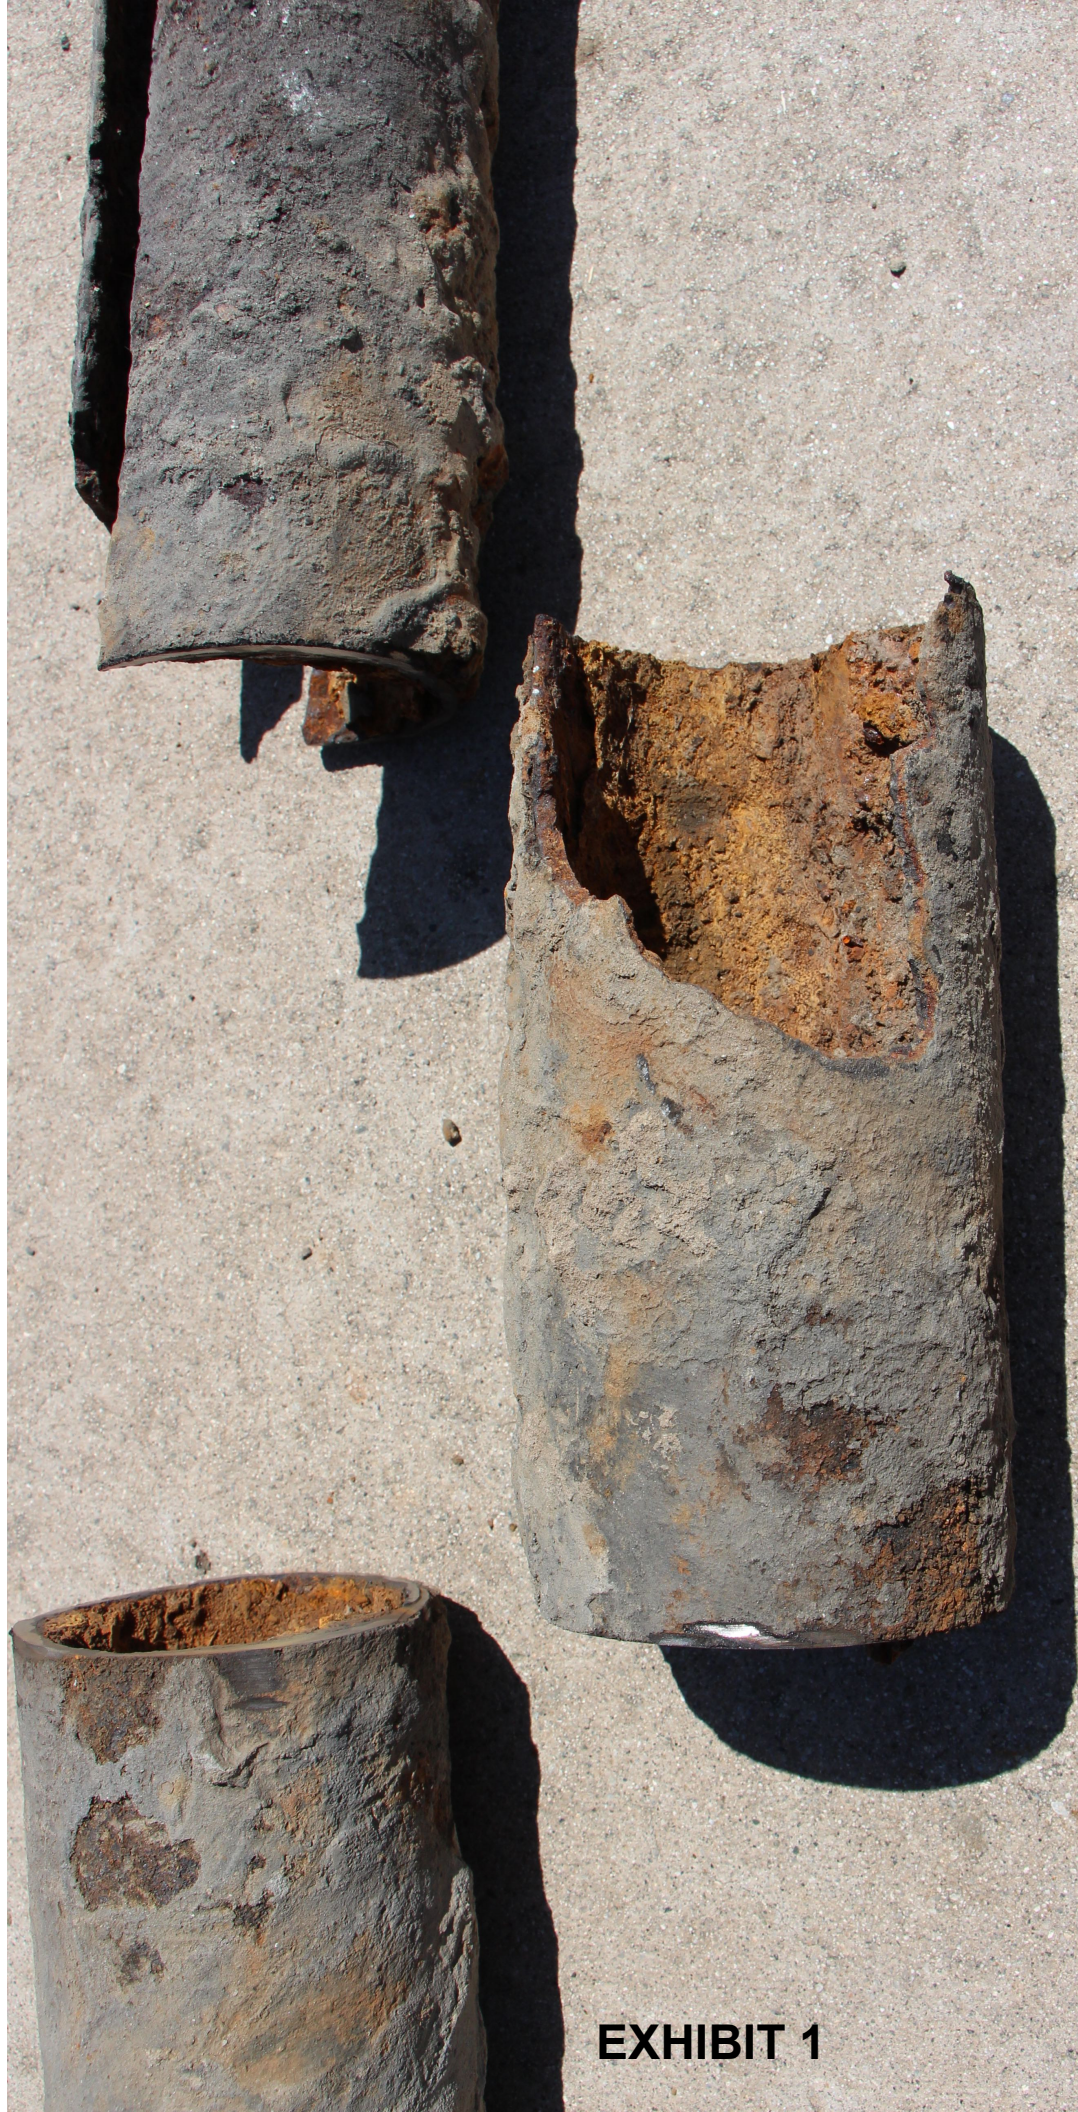
PHOTOGRAPH NO. 3 - 6/13/17

Cast iron sewer pipe specimen removed from 24608 Neptune Avenue by homeowner on or about 8/31/16.

This pipe section does not exhibit a naturally occurring protective scale and has severely corroded.

Photograph No. 3, attached below, shows a cast iron sewer pipe segment provided by a homeowner. This pipe segment does not possess a protective outer scale and shows severe signs of corrosion. This pipe is no longer in a serviceable condition and would have been leaking directly into the soil prior to its removal.
